### City of Simi Valley Flood Damages

25-Year Flooded Parcels: Estimated Flood Depth and Type  
 Upper Calleguas Creek Watershed Management Strategy Study

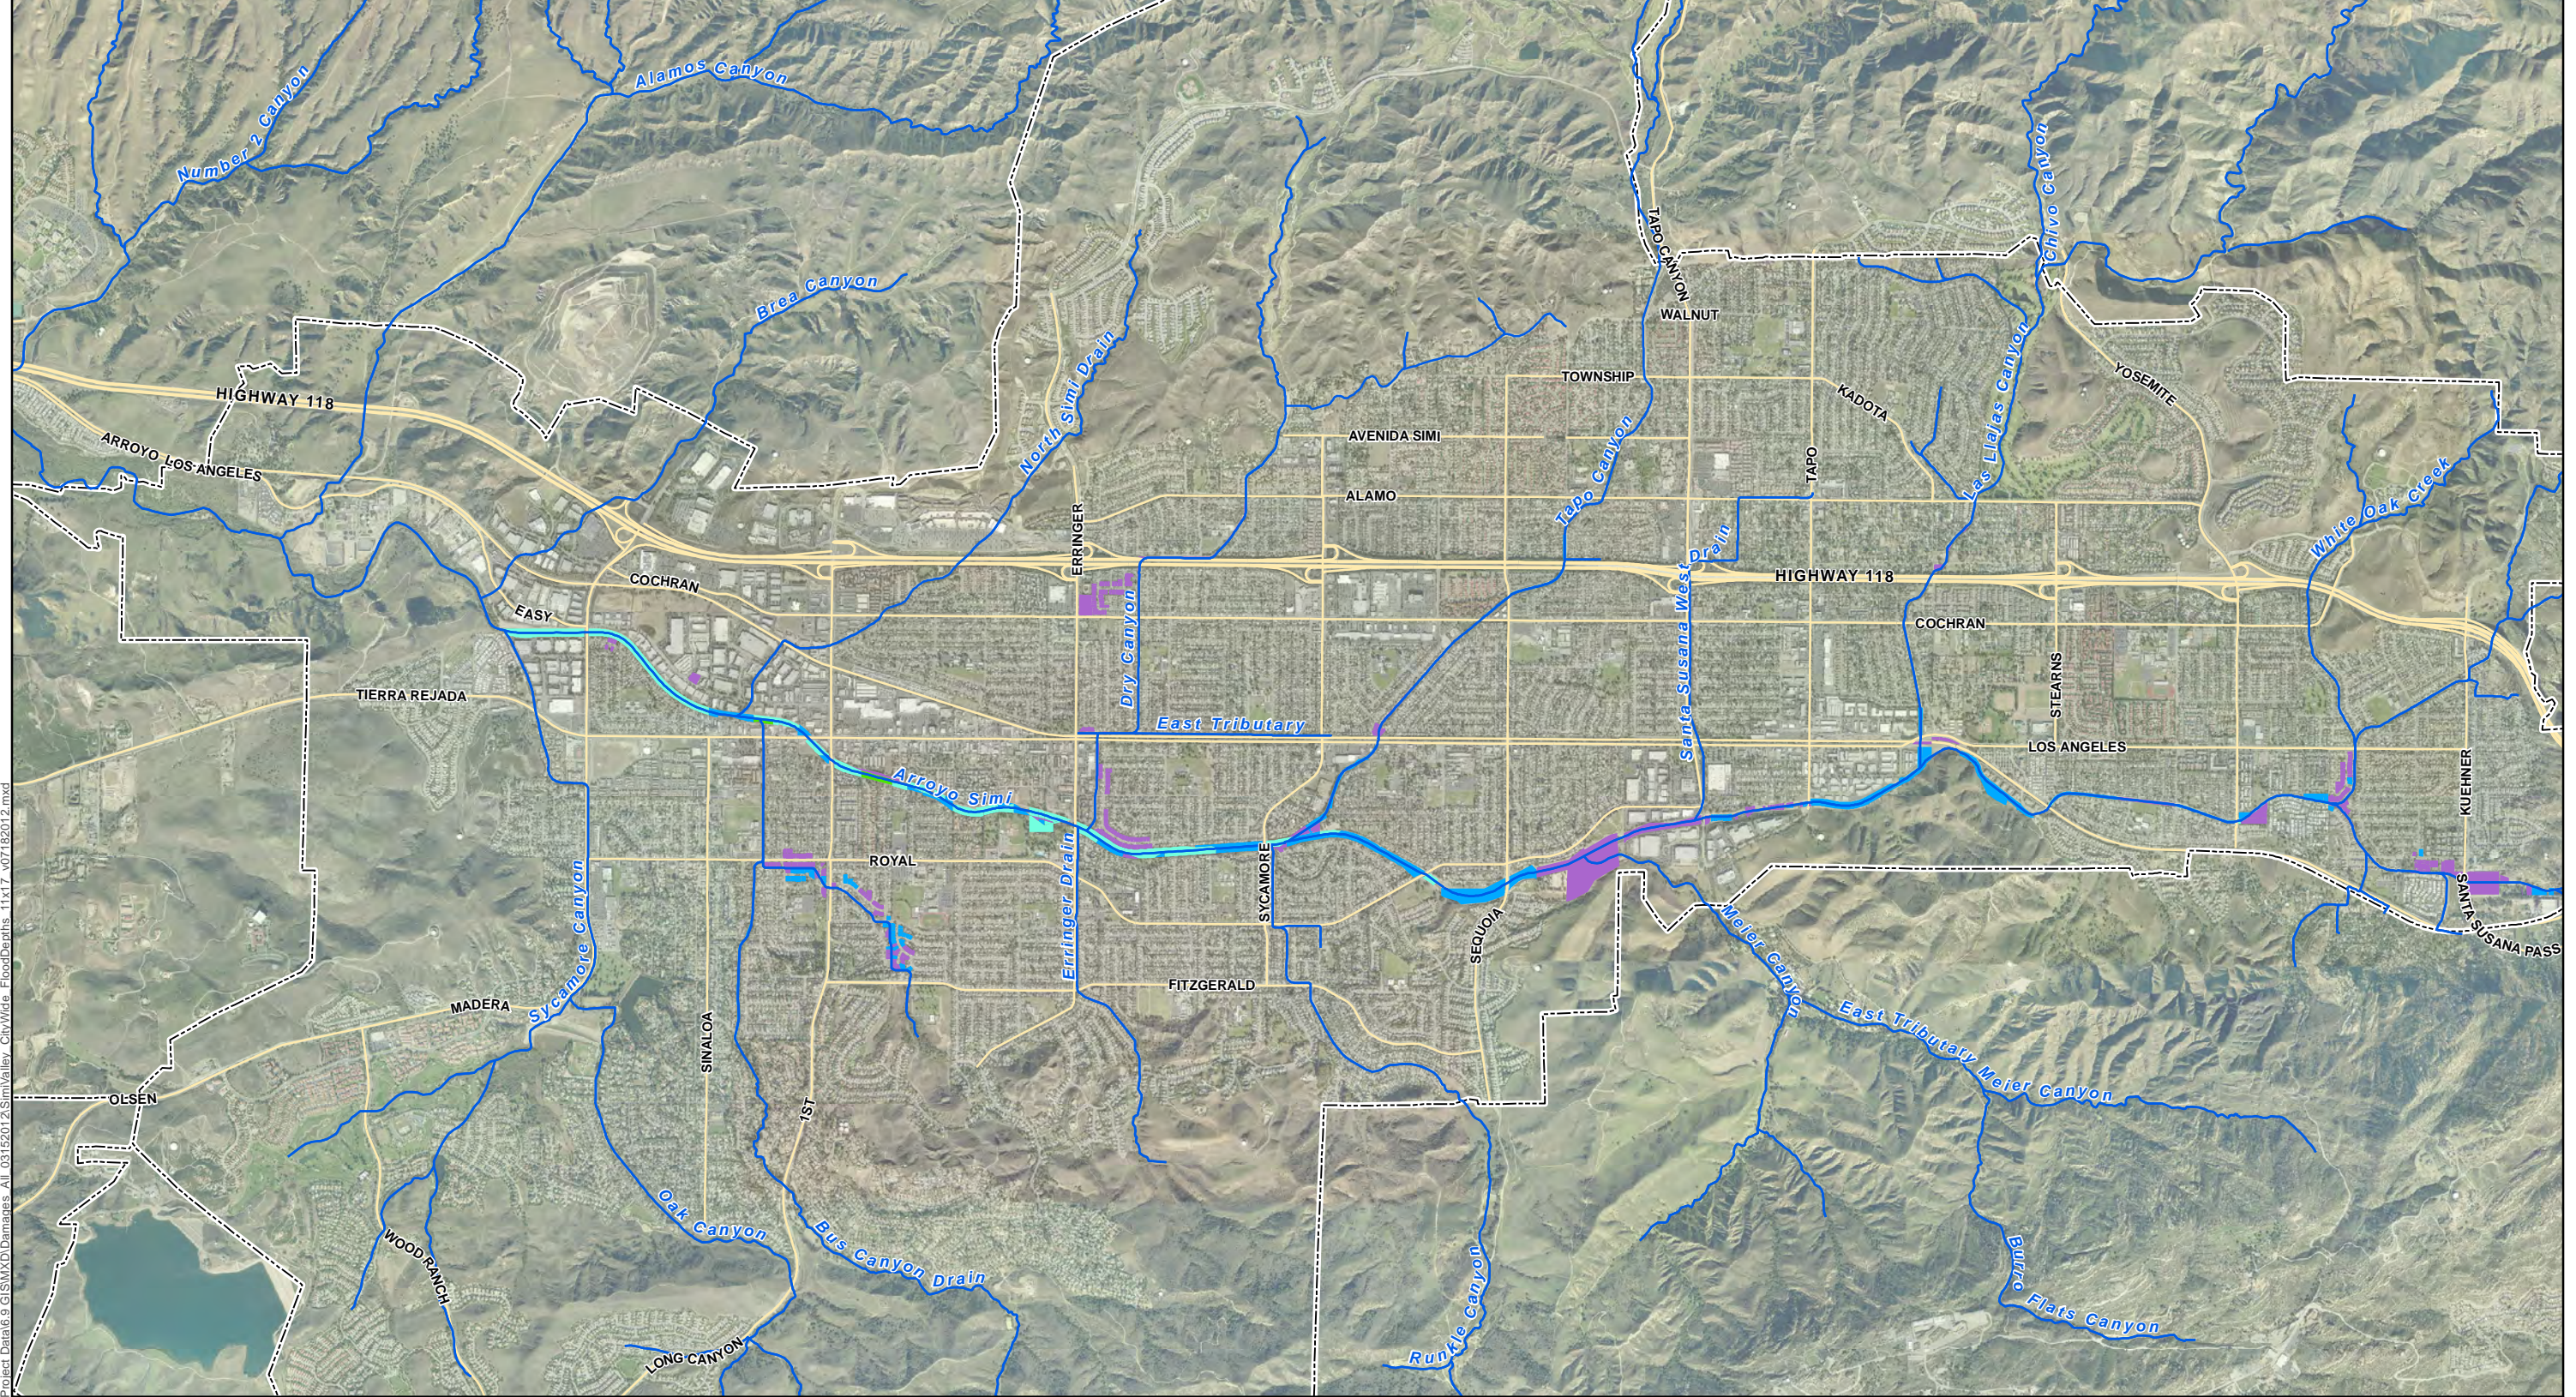
<b>Estimated Flood Depth (ft)</b>	<span style="color: green;">■</span> 2 (1.8 - 2.3)	
<span style="color: purple;">■</span> 0.5 (0.5 - 0.8)	<span style="color: yellow;">■</span> 2.5 (2.3 - 2.8)	
<span style="color: cyan;">■</span> 1 (0.8 - 1.3)	<span style="color: orange;">■</span> 3 (2.8 - 3.3)	
<span style="color: lightblue;">■</span> 1.5 (1.3 - 1.8)	<span style="color: magenta;">■</span> > 3 (3.3+)
